Monitoring Data Record

Project Title: R-210C (Sites 4 and 5) COE Action ID: 1993-0-0570

Stream Name: unnamed tributary to the Little Crane Creek DWQ Number: 010404

# UT Little Crane Creek

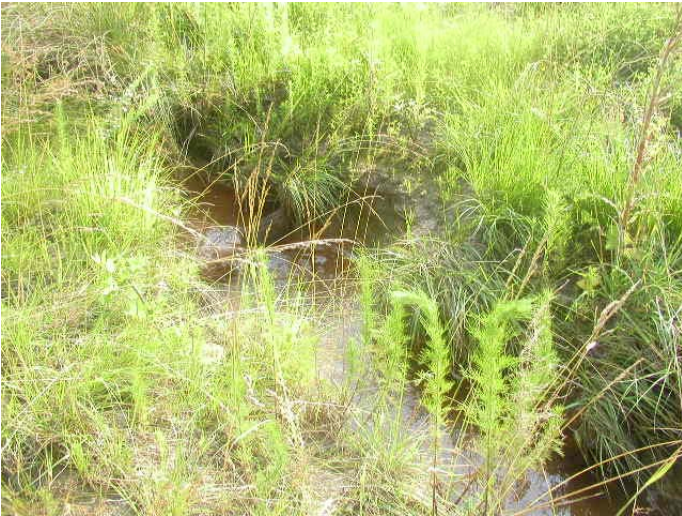
Date Inspected	Sta. 23+60	Sta. 22+80	Station Number	Station Number	Station Number
Structure Type		Log Vane			
Is water piping through or around structure?					
Head cut or down cut present?	Headcut				
Bank or scour erosion present?		Bank Erosion			
Other problems noted?

Bank erosion below log vane @ Sta. 22+80
